February 12, 2012

**Date and time of inspection:**  
**Property location:**  
**Inspector:**

February 12, 2012 at 9:00 am  
**521 5<sup>th</sup> Street**  
Tim Raufer

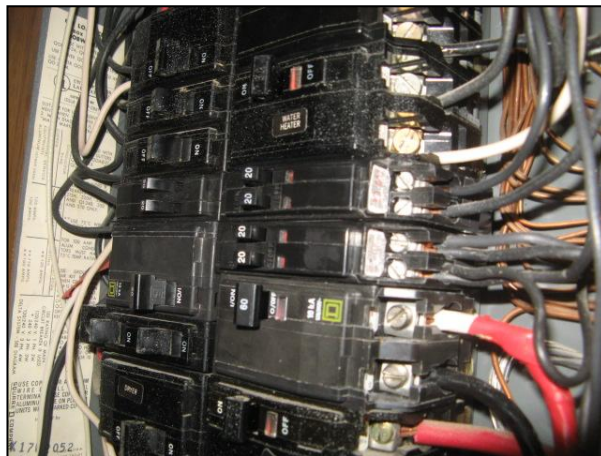
a. There were two "double taps" on one of the half sized 20-amp circuit breakers at the left side of the main electric panel. A "double tap" occurs when there are two wires connected to one terminal on an overload protection device (breaker).

The panel and breakers were manufactured by Square D. Certain breakers manufactured by Square D are designed to accept multiple wires taps. The double tapped breaker was

not designed to accept multiple wires, and this is not a recommended installation. The circuits in question should be reconfigured to eliminate the double tap.

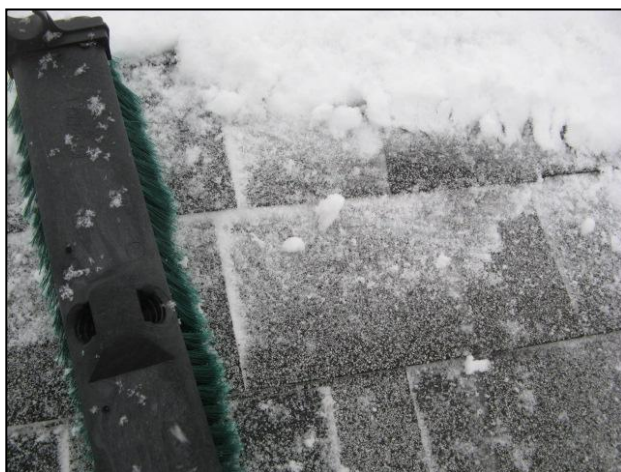
3. The roof was snow covered at the time of the inspection. Shingles on the back (west facing) roof was observed from a ladder at the eaves by sweeping snow from several shingles. There was a heavy-weight asphalt shingle observed. There did not appear to be signs of significant cracking, granule loss or deterioration due to age. The shingles, gutters, and ridge vents on the subject unit and the neighboring units appeared to be the same. It is understood that new roofs were installed approximately 5 years ago. You should consult with the homeowner's association regarding this. The typical service life for this type of shingle is approximately 25-30 years.

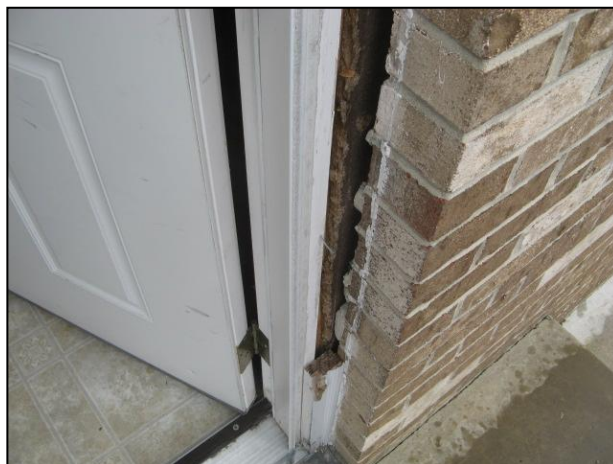
4. The brick moulding was damaged and lacking from the right side of the back entry door. Replacement of the brick mould is recommended. Although a storm door frame had been installed, there was no storm door. Replacement of the storm door is recommended as well. You should consult with a carpenter or handyman regarding this.

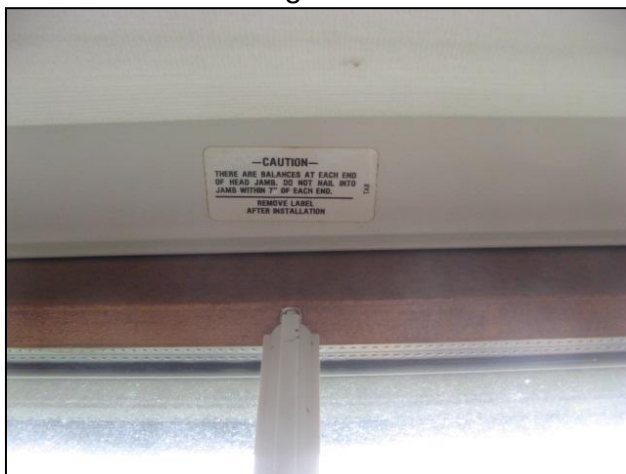
5. There was a single defective sash balance string on the Andersen window at the back left bedroom. The string did not retract when the window was opened. This will make the window difficult to operate and strain the other remaining sash balance.

On Andersen windows, there is a spring balance located at the top of the window, which should retract the string and counter-balance the window. If a trim nail was installed through the spring whenever the window casing was installed, it will prevent the spring from retracting properly. You should consult with a carpentry or window contractor familiar with Andersen windows regarding this. A typical installation sticker from an Andersen window (in a different property) can be seen in the accompanying photo.

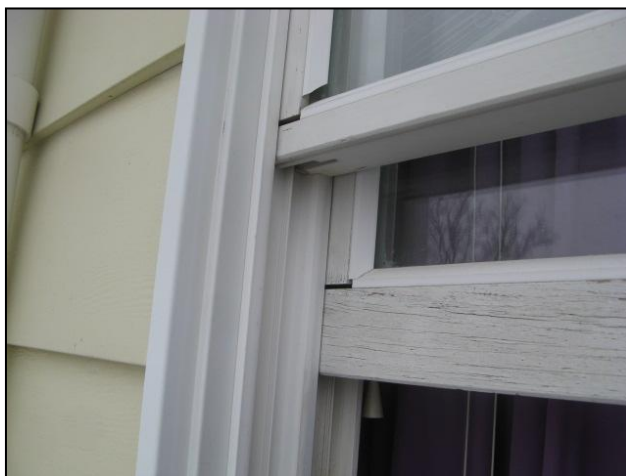
There was separation on some of the sash frame joints on one of the Andersen windows in the back right bedroom. This condition is illustrated in the accompanying photo. Early signs of separation were also observed on the sash frames at the front second floor windows. This prevented the windows from closing/locking fully. Repair of the damaged sash frames is recommended.

You should consult with a contractor who is familiar with Andersen windows regarding repair of these items.

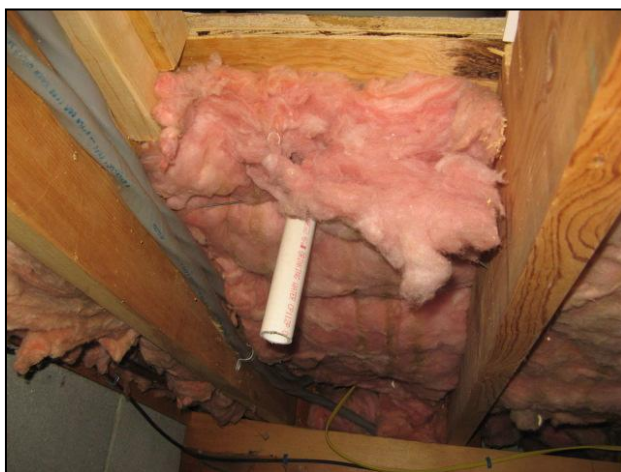
c. The drain from the hot water tank overflow pan was discharging directly into the crawlspace. Whenever the water had been turned on to the property at the beginning of the inspection, the hot water tank drain was open and the tank was overflowing directly into the crawlspace. As a future improvement, it is recommended that the hot water tank overflow pan be connected to a drain pipe in the crawlspace, to avoid flooding the crawlspace in the event of a leak.

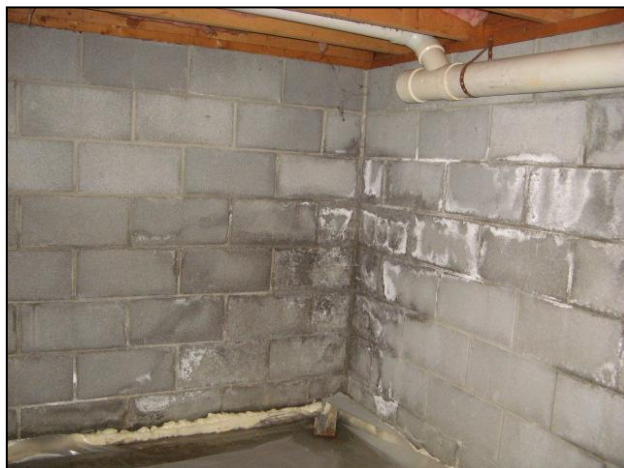
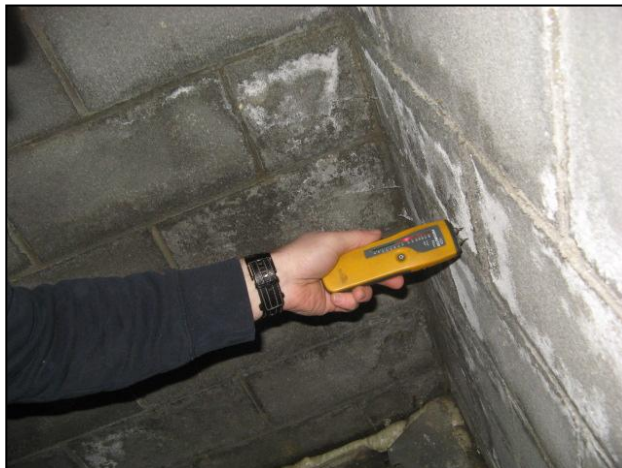
c. There was staining, efflorescence and signs of past water penetration at the back left corner of the crawlspace. This condition is illustrated in the accompanying photo. Some of the stained areas were wet when checked with an electronic moisture meter at the time of the inspection.

As per our conversation, there was a downspout from the roof drainage system discharging directly adjacent to the foundation at this corner of the exterior. The downspout should be extended to discharge water downhill, away from the house.

The joint between the back patio and the foundation should be re-sealed periodically with high-quality masonry caulking to prevent water entry at the joint.

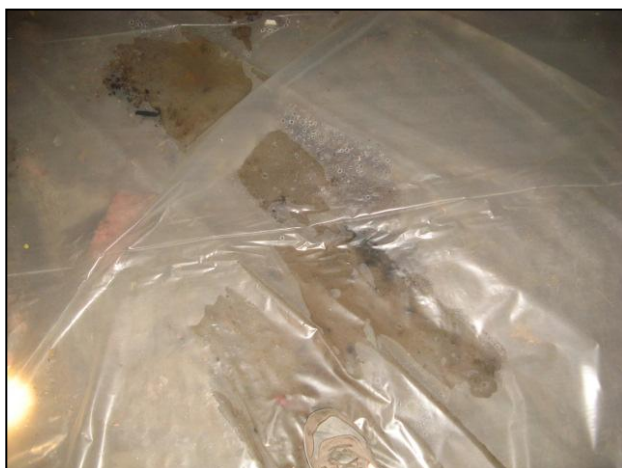
Water droplets and ponding was observed below the vapor barrier at several areas at the back of the crawlspace. The crawlspace should be observed for signs of water penetration

over time. If frequent water penetration, and a lack of drying, becomes problematic, a French drain system may be appropriate.

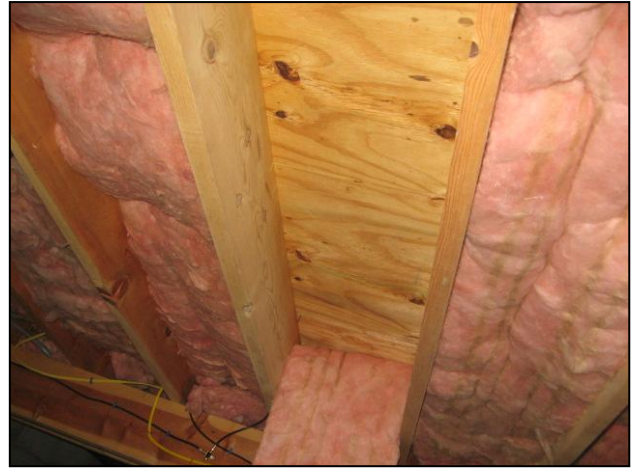
d. There was insulation dislodged at various areas of the crawlspace. The dislodged insulation should be reinstalled or re-secured. As per our conversation, recommended minimum insulation levels have increased substantially since the house was constructed and upgrading insulation should be considered as a future improvement.

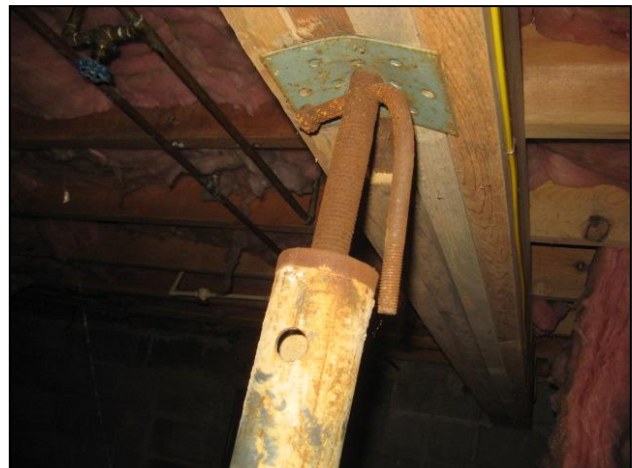
g. The metal plate at the top of steel column supporting the wood beam at the middle of the crawlspace was deformed and it is recommended that an additional steel plate be installed to help distribute the weight of the beam to the column more evenly. You should consult with a carpenter or handyman regarding this.

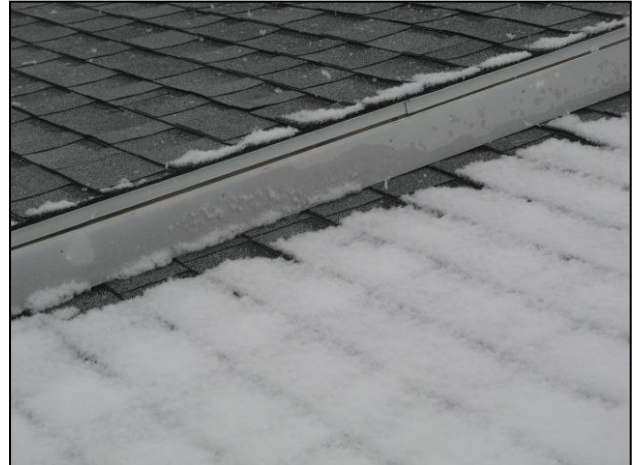
8. The aluminum counter flashing that covers the top of the step flashing on the subject house, and tucks below the drip edge on the neighboring property was dislodged and should be re-secured so that water does not penetrate behind the counter flashing. This condition is illustrated in the accompanying photo.

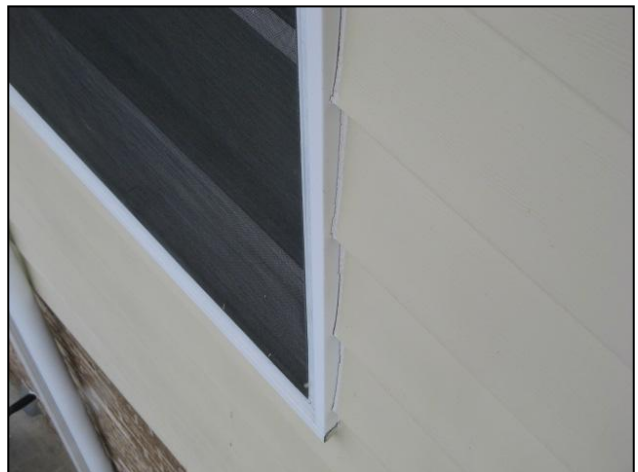
9. There were open caulk joints between the vinyl siding and the windows at the back of the house. The open joints should be re-caulked periodically as a maintenance item. This condition is illustrated in the accompanying photo.

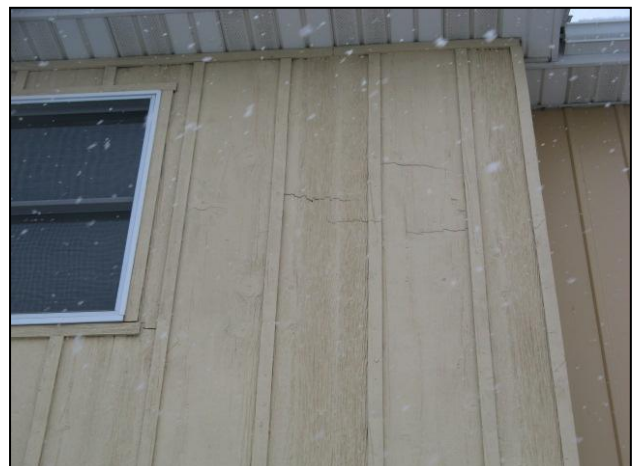
11. The synthetic foam siding at the front of the house is believed to be original to the property, and is showing signs of deterioration and weathering due to age. There were cracks in the siding to the right side of the 2<sup>nd</sup> floor. In general, the siding appeared to be in serviceable condition, however, eventual replacement should be considered as a future

improvement.

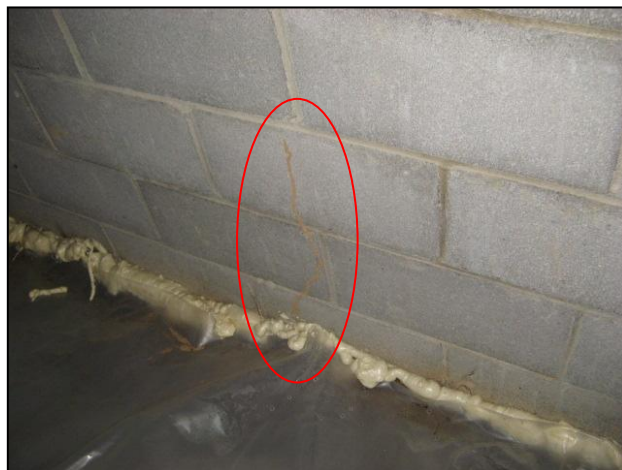
Mud sheltered tunnels from termites were observed on the foundation wall at the front of the crawlspace. No live insects were observed. There did not appear to be mud sheltered tunnels or evidence of termite activity on the framing at the front of the basement. The framing was observed at a representative number of areas by removing insulation. Periodic re-inspection for termite activity is recommended. You should consult a pest control contractor regarding this.
